2018 Pre-Treatment Survey of Eurasian Watermilfoil

**Round & Little Round Lakes, Sawyer County, Wisconsin
-survey completed July 2018-**

**Survey and report completed by:
Aquatic Plant & Habitat Services, LLC
Sara Hatleli
N4888 Beck Rd. Taylor, WI 54659
715-299-4604, Sarahatleli97@gmail.com**

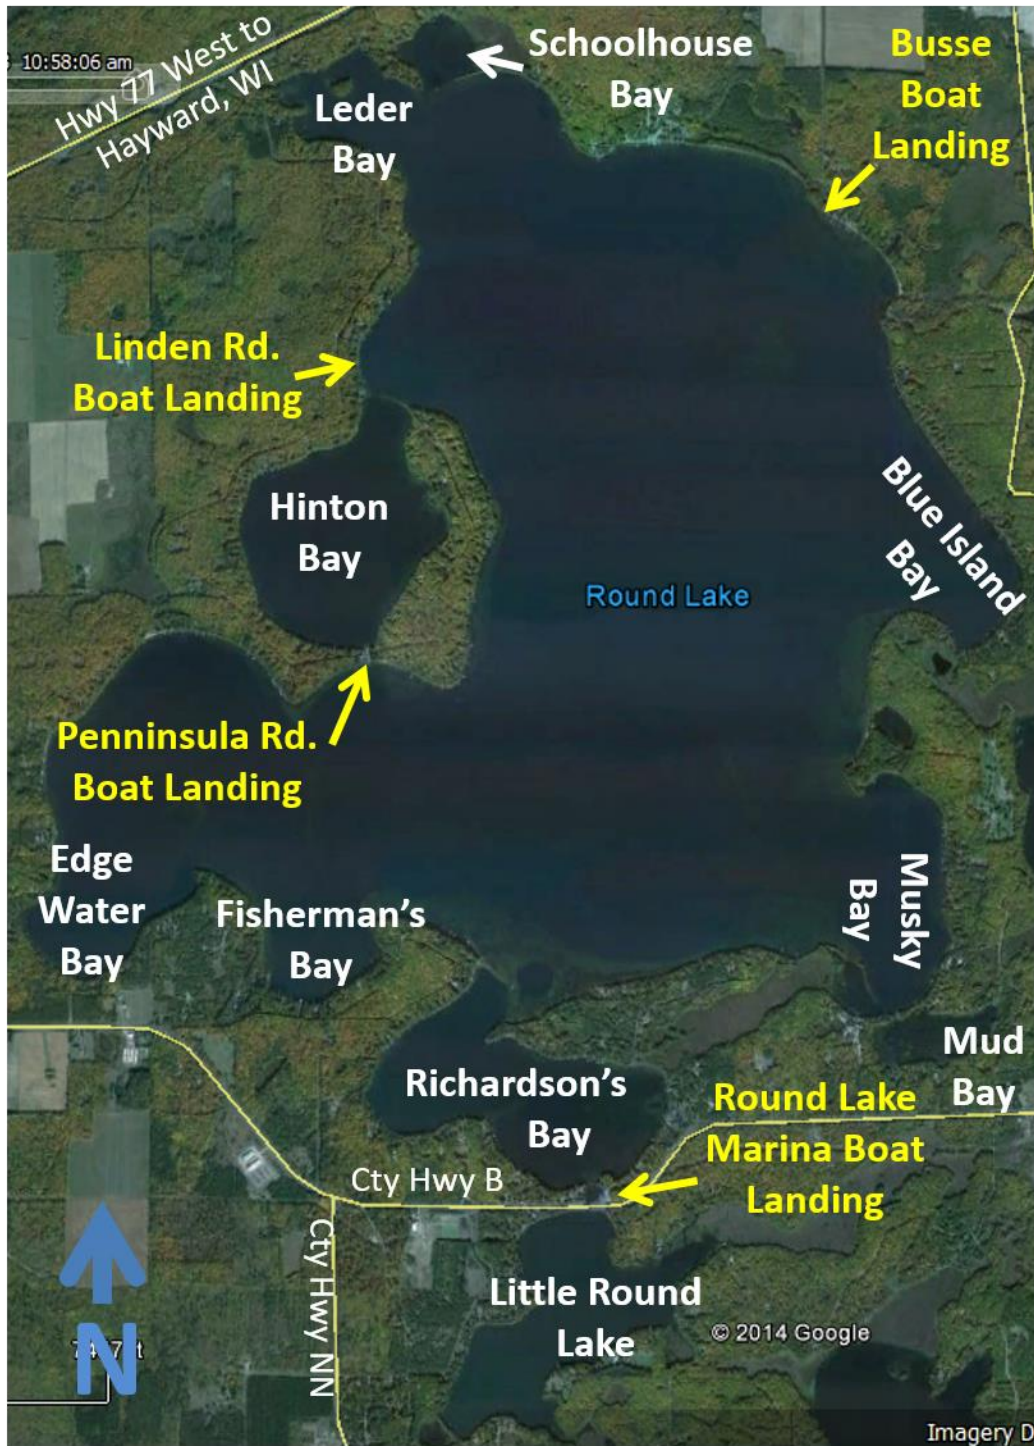
Figure 1 – Round Lakes Map

Round Lake is a seepage lake located in Sawyer County, Wisconsin with a surface area of 3,324 acres. The maximum depth is 74 feet and the mean depth is 33 feet. Connected by a narrow channel to the south is Little Round Lake, also considered a seepage lake with a surface area of 179 acres, maximum depth of 38 feet and mean depth of 12 feet. Although the lakes have their own unique Water Body Identification Code (WBIC, Round 2395600, Little Round 2395500), they are sometimes referred to as the Round Chain and the Round Lake Property Owners Association serves both lakes. The lakes are situated approximately 7 miles east of Hayward, Wisconsin (Figure 1). Water clarity for Little Round Lake is moderately clear. Little Round Lake is considered mesotrophic and has abundant vegetation. Water clarity for Round Lake is very high and the lake is considered oligotrophic with low nutrients and sparse vegetation.

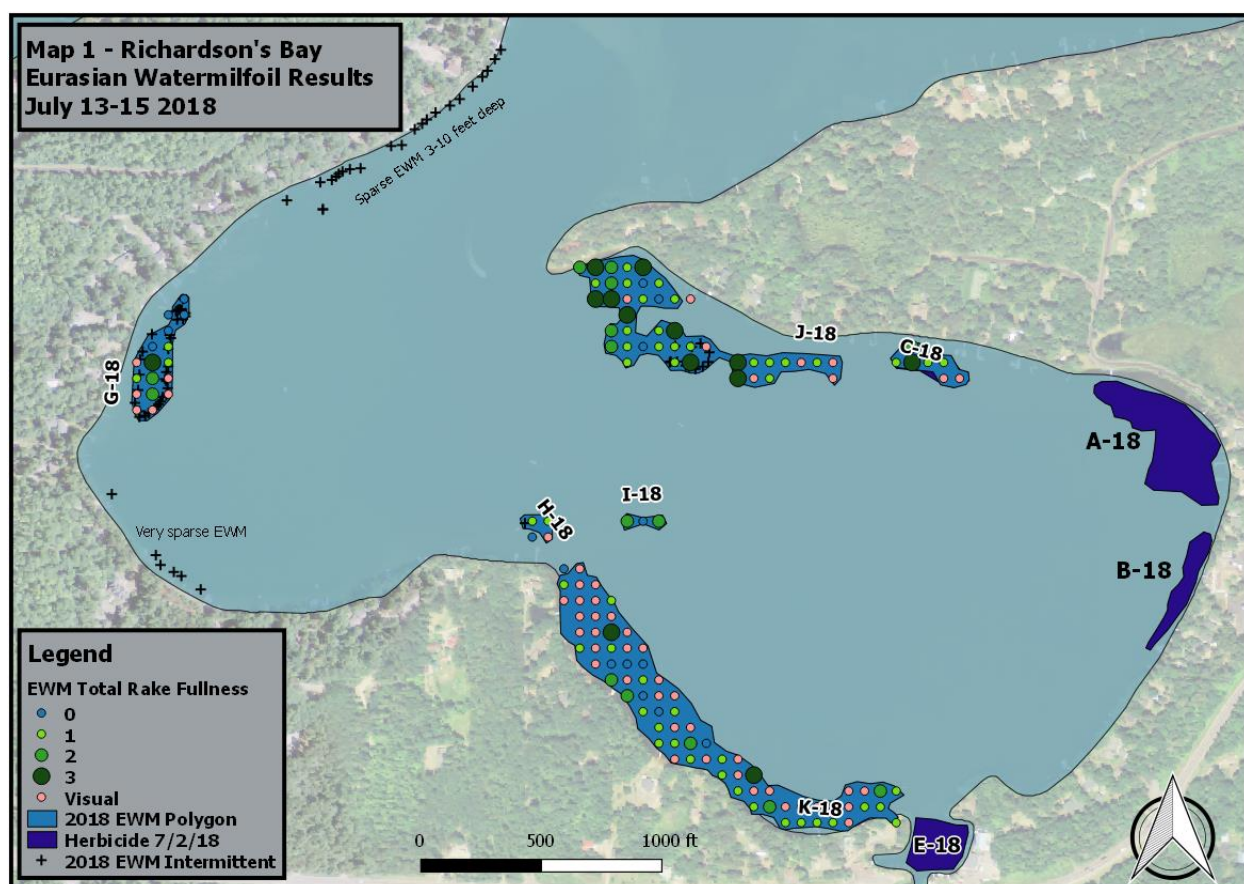
Figure 4 – Richardson’s Bay EWM Map

There were a total of 147 survey points visited in polygons C18, G18, H18, I18, J18, and K18 (see Table 9 for acreage) with vegetation present at 144 of those survey points (Figure 4). Eurasian watermilfoil was present at 78 survey points and was a visual observation (not on the rake but within 6 feet of the survey point) at another 52 points. The overall littoral frequency of EWM in the polygons was 53%, this only includes sites where EWM was found on the rake. If visual observations are included in the calculation, the littoral frequency of EWM increases to 88%. EWM was dense and near the surface or canopied at all polygons with the exception of the northern half of K18. Sparse EWM was documented along the northwest and southwest shore, but these areas were not dense enough to create a polygon and conduct a point-intercept survey. Polygons A18, B18, and E18 were treated with herbicide in 2018 (see INTRODUCTION for more information). There were 25 native species found in Richardson’s Bay and the three most common species were wild celery, fern pondweed, and common waterweed (Table 3). No DASH was done in Richardson’s Bay in 2018.

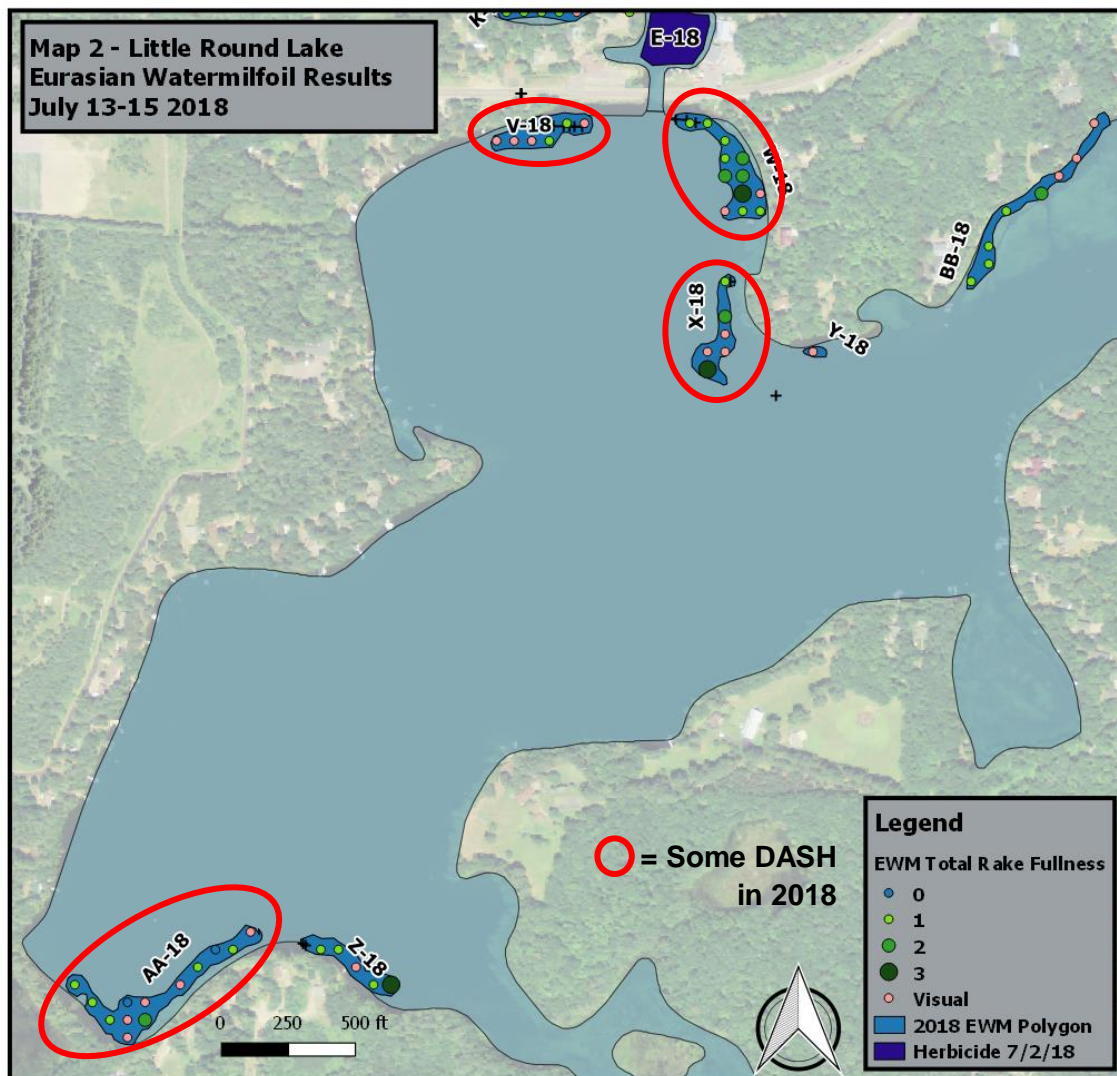
Figure 5 – Little Round Lake EWM Map

There were a total of 53 survey points visited in polygons V18, W18, X18, Y18, Z18, AA18, and BB18 (see Table 9 for acreage) with vegetation present at 52 of those survey points (Figure 5). Eurasian watermilfoil was present at 32 survey points and visually observed (not on the rake but within 6 feet of the survey point) at another 19 points. The overall littoral frequency of EWM in the polygons was 60%, this only includes sites where EWM was found on the rake. If visual observations are included in the calculation, the littoral frequency of EWM increases to 99%. EWM was canopied in some locations (especially AA18) but was also well below the surface in others while the density was high in most locations (see Table 9 for more on density and plant height). No herbicide treatment was done on Little Round Lake in 2018 or 2017. There were 31 native species documented in Little Round Lake and the three most common species were fern pondweed, common waterweed, and wild celery (Table 4). DASH technicians on two pontoons removed 30,660 pounds of EWM from Little Round Lake in 34 hours (68 DASH-boat hours).

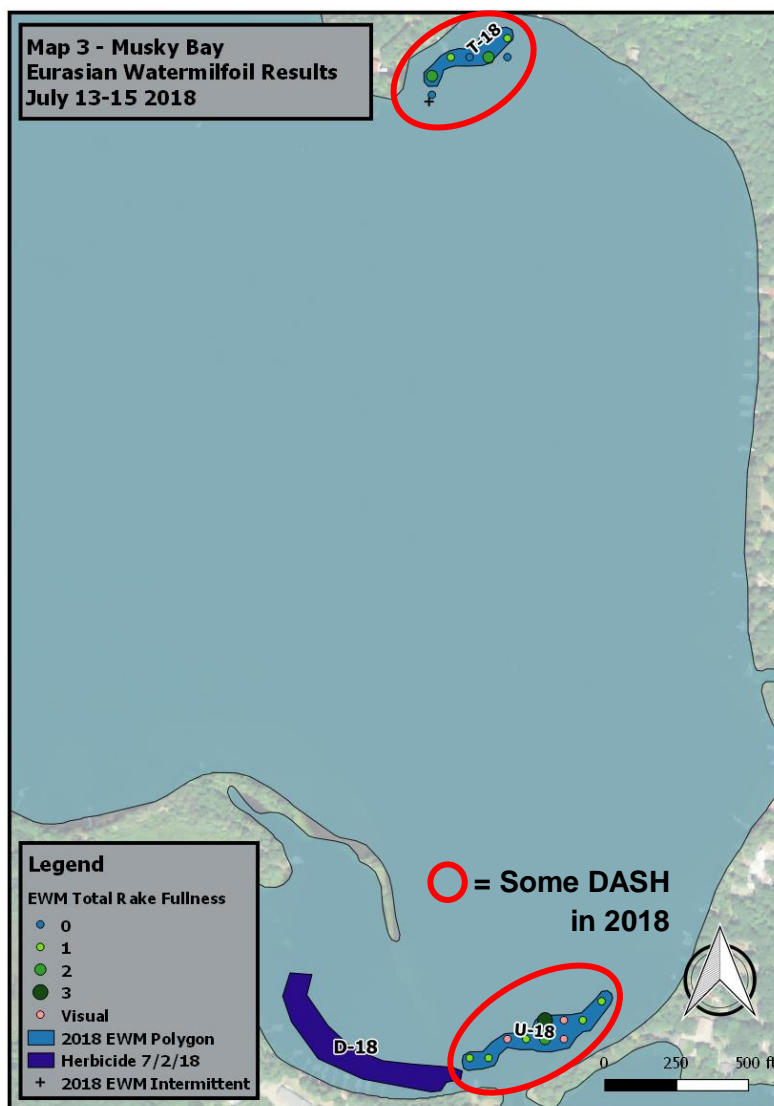
Figure 6 – Musky Bay EWM Map

There were a total of 18 survey points visited in polygons T18 and U18 (0.571 and 1.023 ac) with vegetation present at all survey points (Figure 6). Eurasian watermilfoil was present at 12 survey points and visually observed (not on the rake but within 6 feet of the survey point) at another 3 points. The overall littoral frequency of EWM in the polygons was 67%, this only includes sites where EWM was found on the rake. If visual observations are included in the calculation, the littoral frequency of EWM increases to 83%. The EWM plant height was well below the surface and density was estimated to be moderate-to-high. Herbicide treatment was done at polygon D18 (see INTRODUCTION for more information). There were 16 native species found and the three most common species were fern pondweed, common waterweed, and flat-stem pondweed. DASH technicians on two pontoons removed 11,410 pounds of EWM from Musky Bay in 16.5 hours (33 DASH-boat hours).

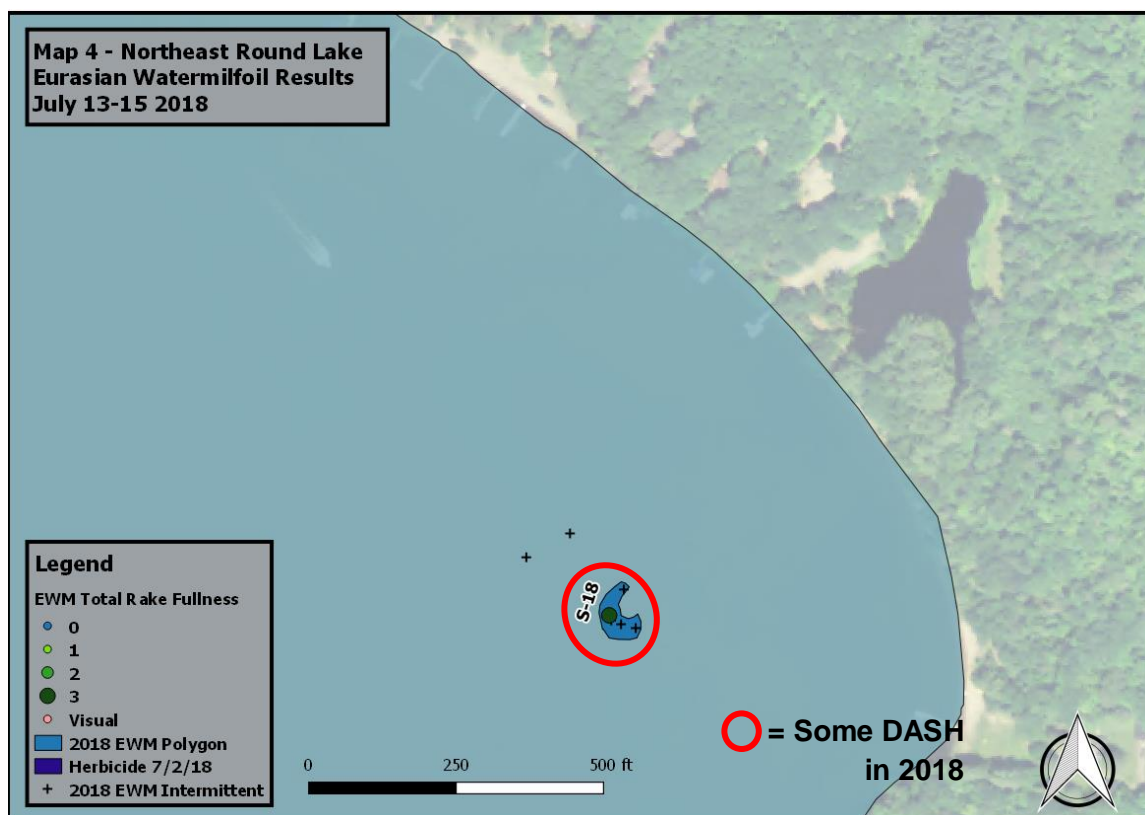
Figure 7 – Northeast Round Lake EWM Map

The northeast area of Round is low in plant abundance with sand and rock substrate. Eurasian watermilfoil was found in a small but dense stand at polygon S18 where one survey point yielded EWM at a rake fullness of “3” but no native species. Another small, dense stand of EWM was likely present to the northwest of S18 (“+” signs in Figure 7) but could not be confirmed the day of surveying because anglers were using that location. Interestingly, an abundance of bait fish was observed at S18 since the EWM was providing structural habitat in an otherwise structure-limited area. These small but dense stands of EWM seem somewhat limited in the ability to expand because the surrounding substrate was rock. DASH technicians on one pontoon removed 490 pounds of EWM from S18 in 3 hours.

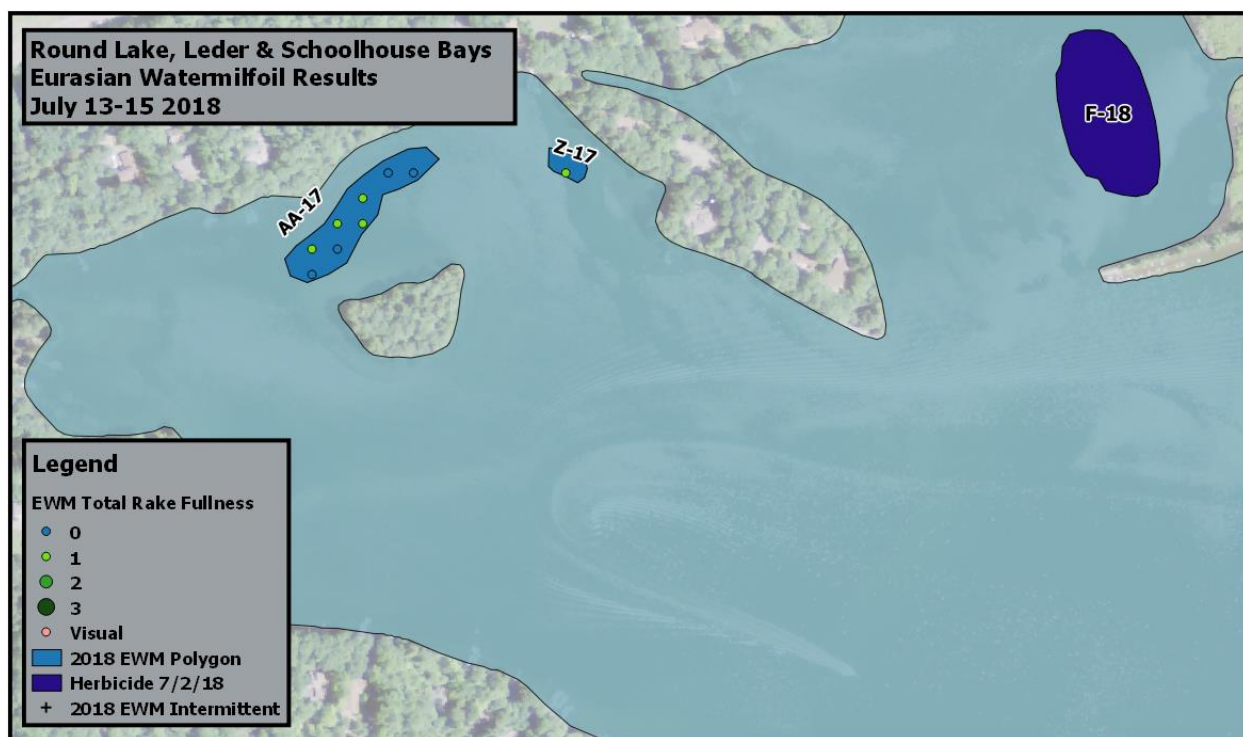
Figure 8 – Leder & Schoolhouse Bays EWM Map

There were a total of 9 survey points visited in polygons Z17 and AA17 (0.134 and 1.01 acres) with vegetation present at all survey points. The survey was completed on June 16th, 2018 in order to visit these locations before herbicides were applied. These were the only herbicide-treated areas surveyed because they were included in the grant-funded project. Eurasian watermilfoil was present at 5 survey points. The overall littoral frequency of EWM in the polygons was 56%. Herbicide treatment was done at polygons F18 (2 acres), Z17, and AA17 (see INTRODUCTION for more information). There were 3 native species found including coontail (1 site), common waterweed (5 sites), and fern pondweed (7 sites). No DASH was performed in Leder or Schoolhouse Bays in 2018.

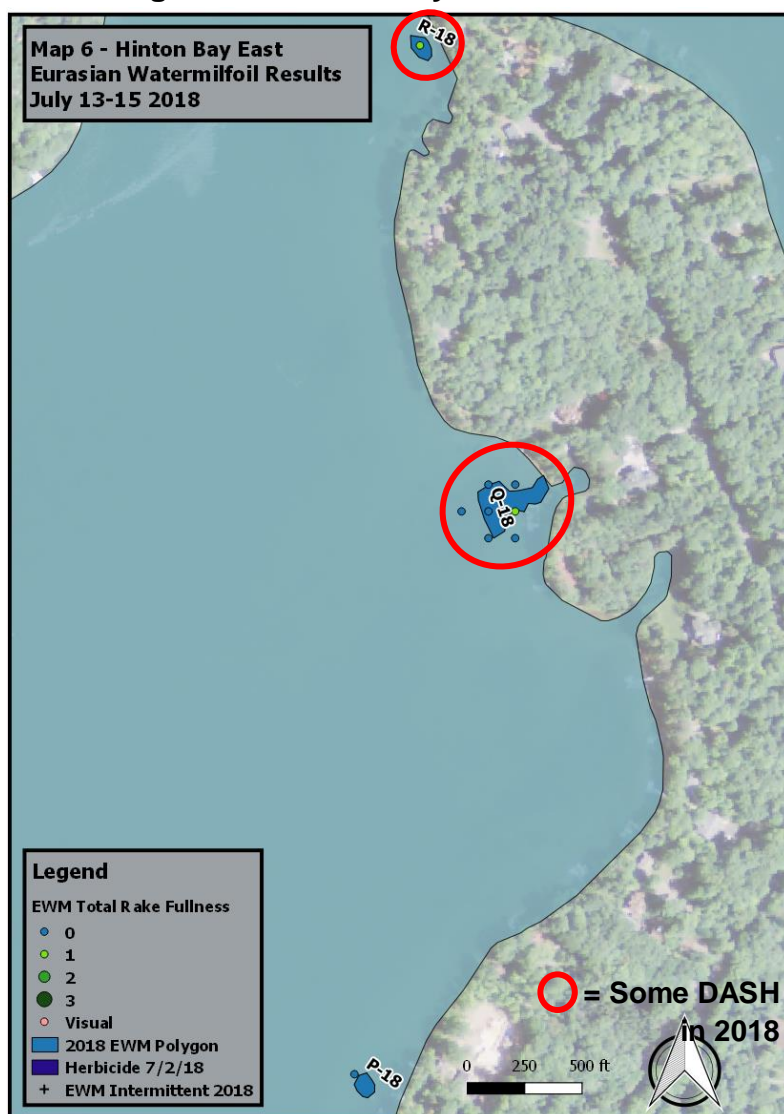
Figure 9 – Hinton Bay East EWM Results

In Hinton Bay there were 30 survey points in polygons N18, O18, P18, Q18, and R18 (see Table 9 for acreage) with vegetation present at 29 points (Figure 9 & Figure 10). Eurasian watermilfoil was present at 6 survey points yielding littoral frequency of EWM in the polygons of 20%. The EWM was found growing at low densities and below the lake surface at most polygons with the exceptions of Q18 and R18, which were high density with EWM near the surface. There were 16 native species found and the three most common species were fern pondweed, northern watermilfoil, and wild celery (Table 6). DASH technicians on two pontoons removed 14,770 pounds of EWM from Hinton Bay in 19.5 hours (39 DASH-boat hours).

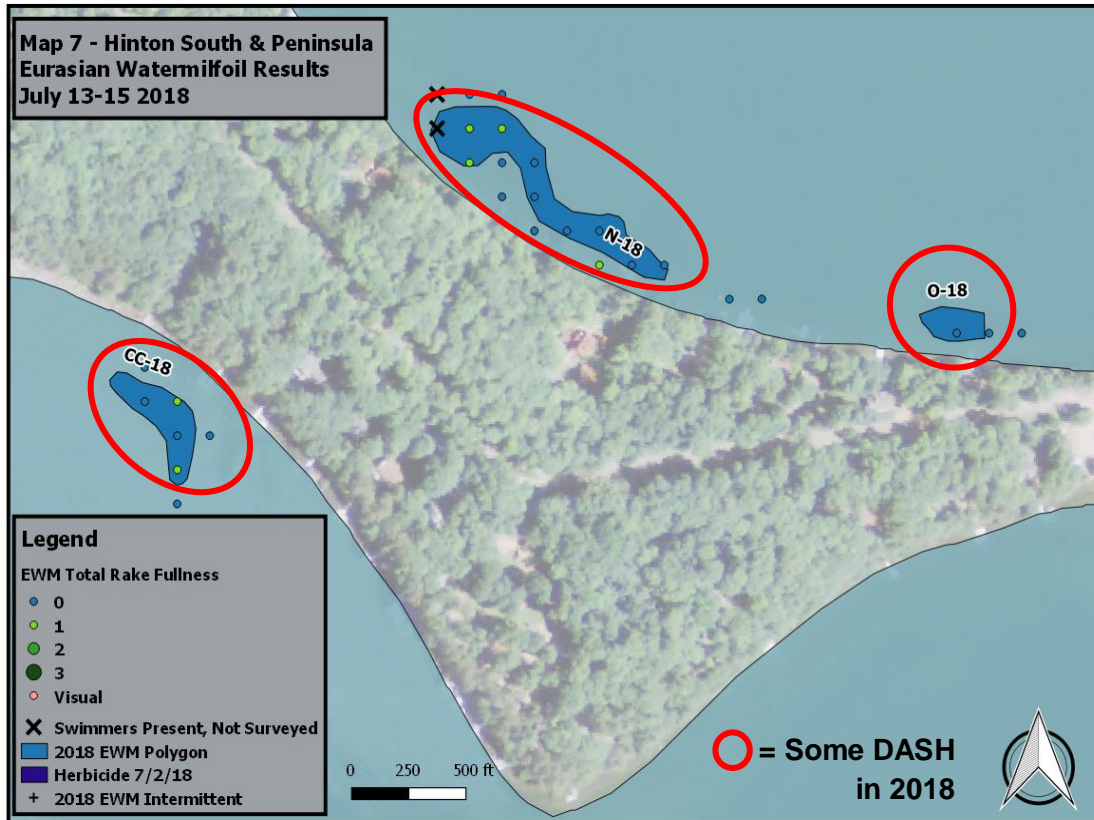
Figure 10 – Hinton Bay South & Peninsula South

There were seven survey points in polygon CC18 located south of the Peninsula (Figure 10) and vegetation was present at all 7 sites (Table 7). Eurasian watermilfoil was found at 2 sites at low density and well below the lake surface. DASH technicians on two pontoons removed 2,940 pounds of EWM from CC18 in 5.5 hours (11 DASH-boat hours).

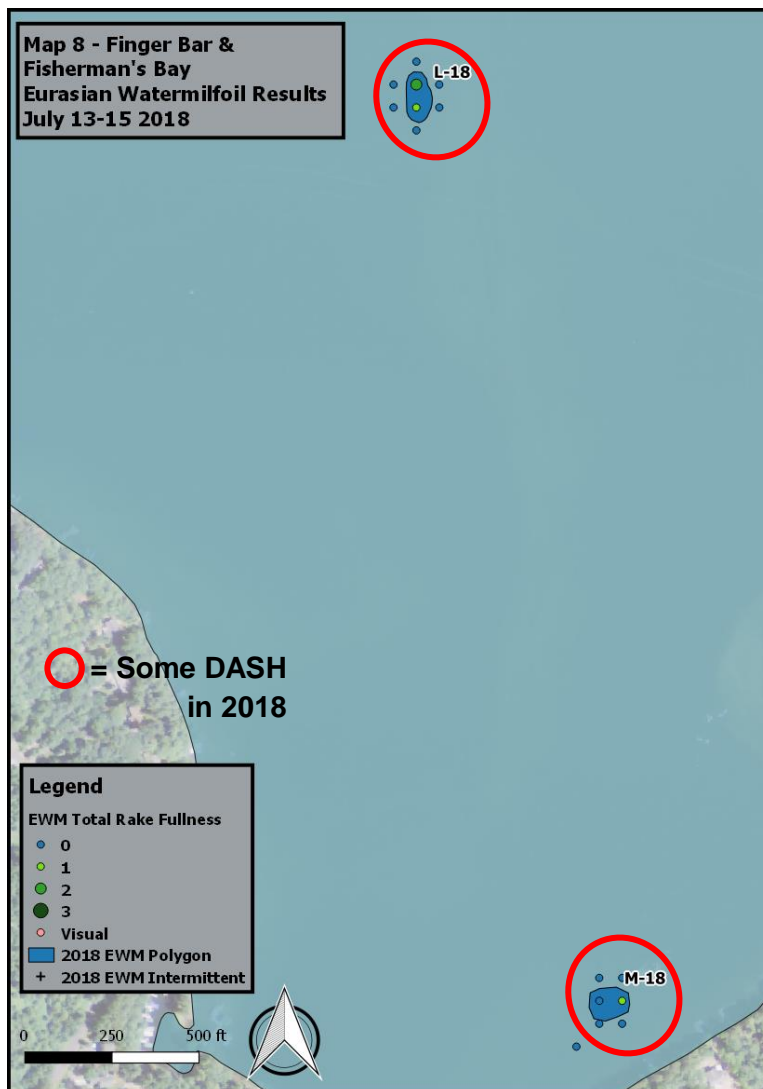
Figure 11 – Finger Bar & Fisherman’s Bay EWM Map

There were a total of 8 survey points visited in and near polygon L18 (Finger Bar, 0.21 ac) with vegetation present at 6 of those points. Eurasian watermilfoil was present at 2 survey points with moderate density and no plants were canopied at the surface. There were 4 native species found including chara (1 site), variable pondweed (1 site), flat-stem pondweed (1 sites), and perfoliate pondweed (1 site). DASH technicians on one pontoon removed 910 pounds of EWM from L18 in 3 hours (3 DASH-boat hours).

There were 7 survey points in and around polygon M18 (Fisherman’s Bay, 0.21 ac) with vegetation present at 6 of those points. Eurasian watermilfoil was found at one survey point at low density and not easily visible from the lake surface (i.e. not hindering navigation or recreation). There were 12 native species found in and around M18 (Table 8). DASH technicians on one pontoon removed 840 pounds of EWM from M18 in 3 hours (3 DASH-boat hours).
