2020 Eurasian Watermilfoil Surveys

Round & Little Round Lakes, Sawyer County, WI

- Surveys Completed August 28-30 & September 4, 2020 –
- Report Completed November 2020 -

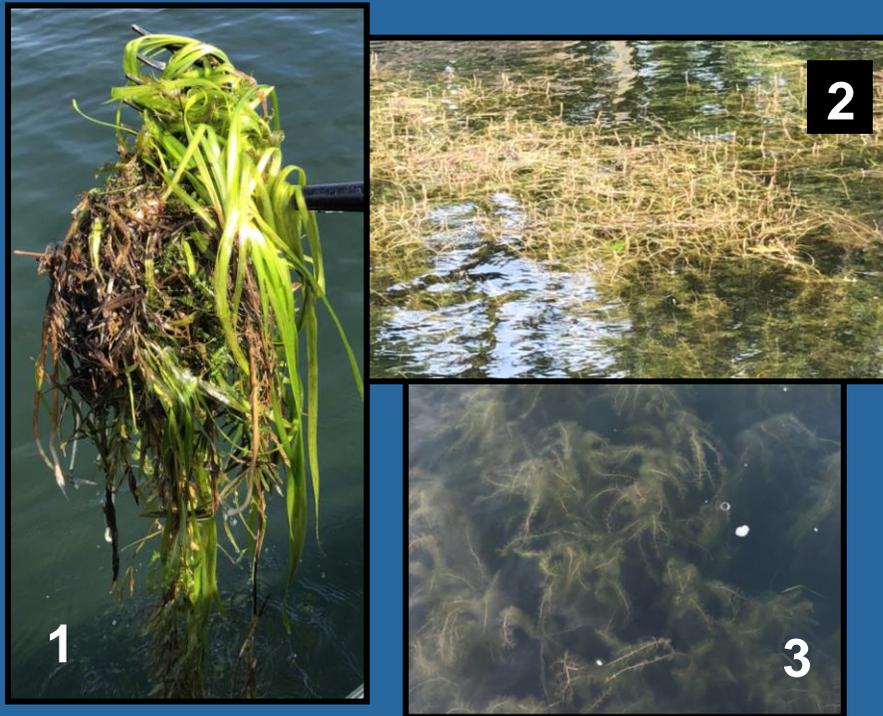
Photos from Cover Page: 1) Survey rake full of water celery mixed with other native species. Water celery was abundant and found throughout both lakes during the survey. 2) Living/healthy Eurasian watermilfoil canopied at the lake surface in Little Round Lake EWM bed EE20. 3) Living/healthy Eurasian watermilfoil near the lake surface from Round Lake bed R19 (photo taken in 2019).

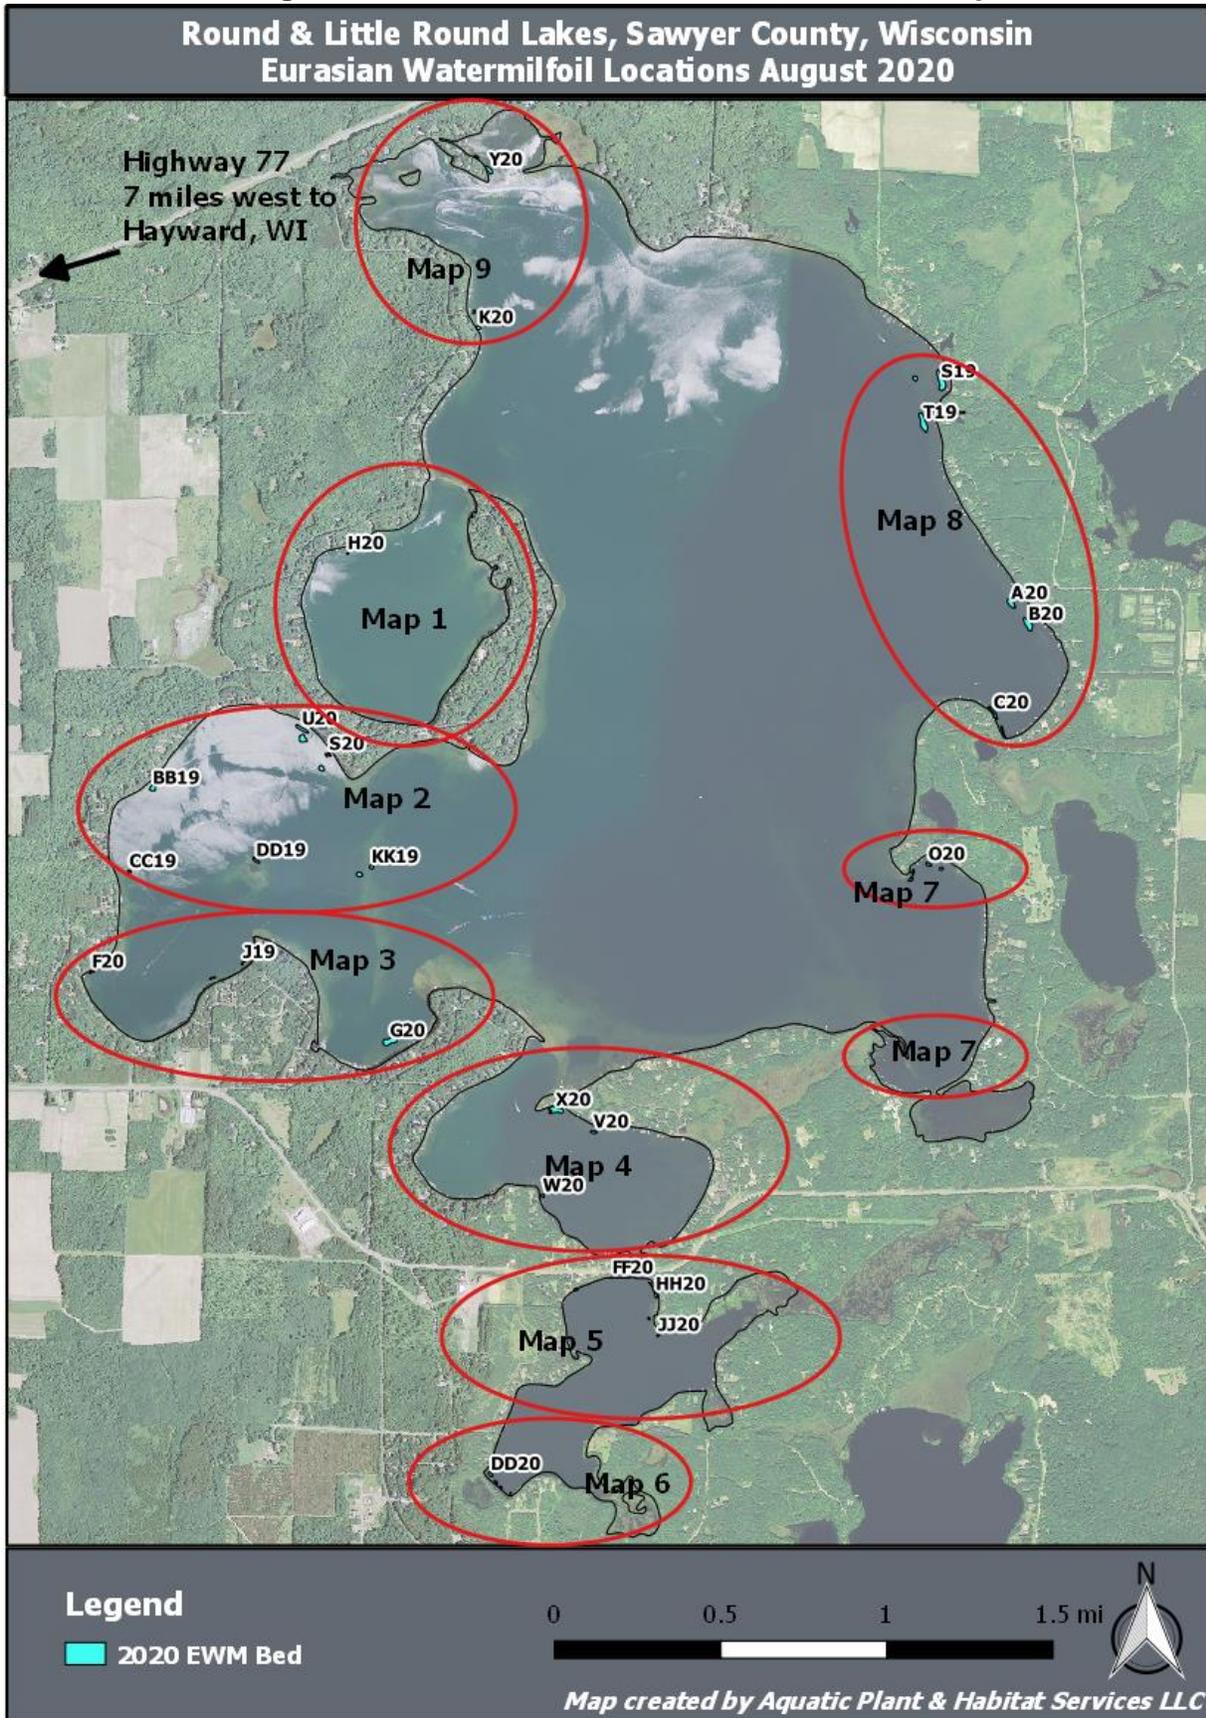
Figure 1 – Round & Little Round Lakes EWM Map

Round Lake is a seepage lake located in Sawyer County, Wisconsin with a surface area of 3,324 acres. The maximum depth is 74 feet and the mean depth is 33 feet. Connected by a narrow channel to the south is Little Round Lake, also considered a seepage lake with a surface area of 179 acres, maximum depth of 38 feet and mean depth of 12 feet. Although the lakes have their own unique Water Body Identification Code (WBIC, Round 2395600, Little Round 2395500), they are sometimes referred to as the Round Chain and the Round Lake Property Owners Association serves both lakes. The lakes are situated approximately 7 miles east of Hayward, Wisconsin (Figure 1). Water clarity for Little Round Lake is moderately clear. Little Round Lake is considered mesotrophic and has abundant vegetation. Water clarity for Round Lake is very high and the lake is considered oligotrophic with low nutrients and sparse vegetation.

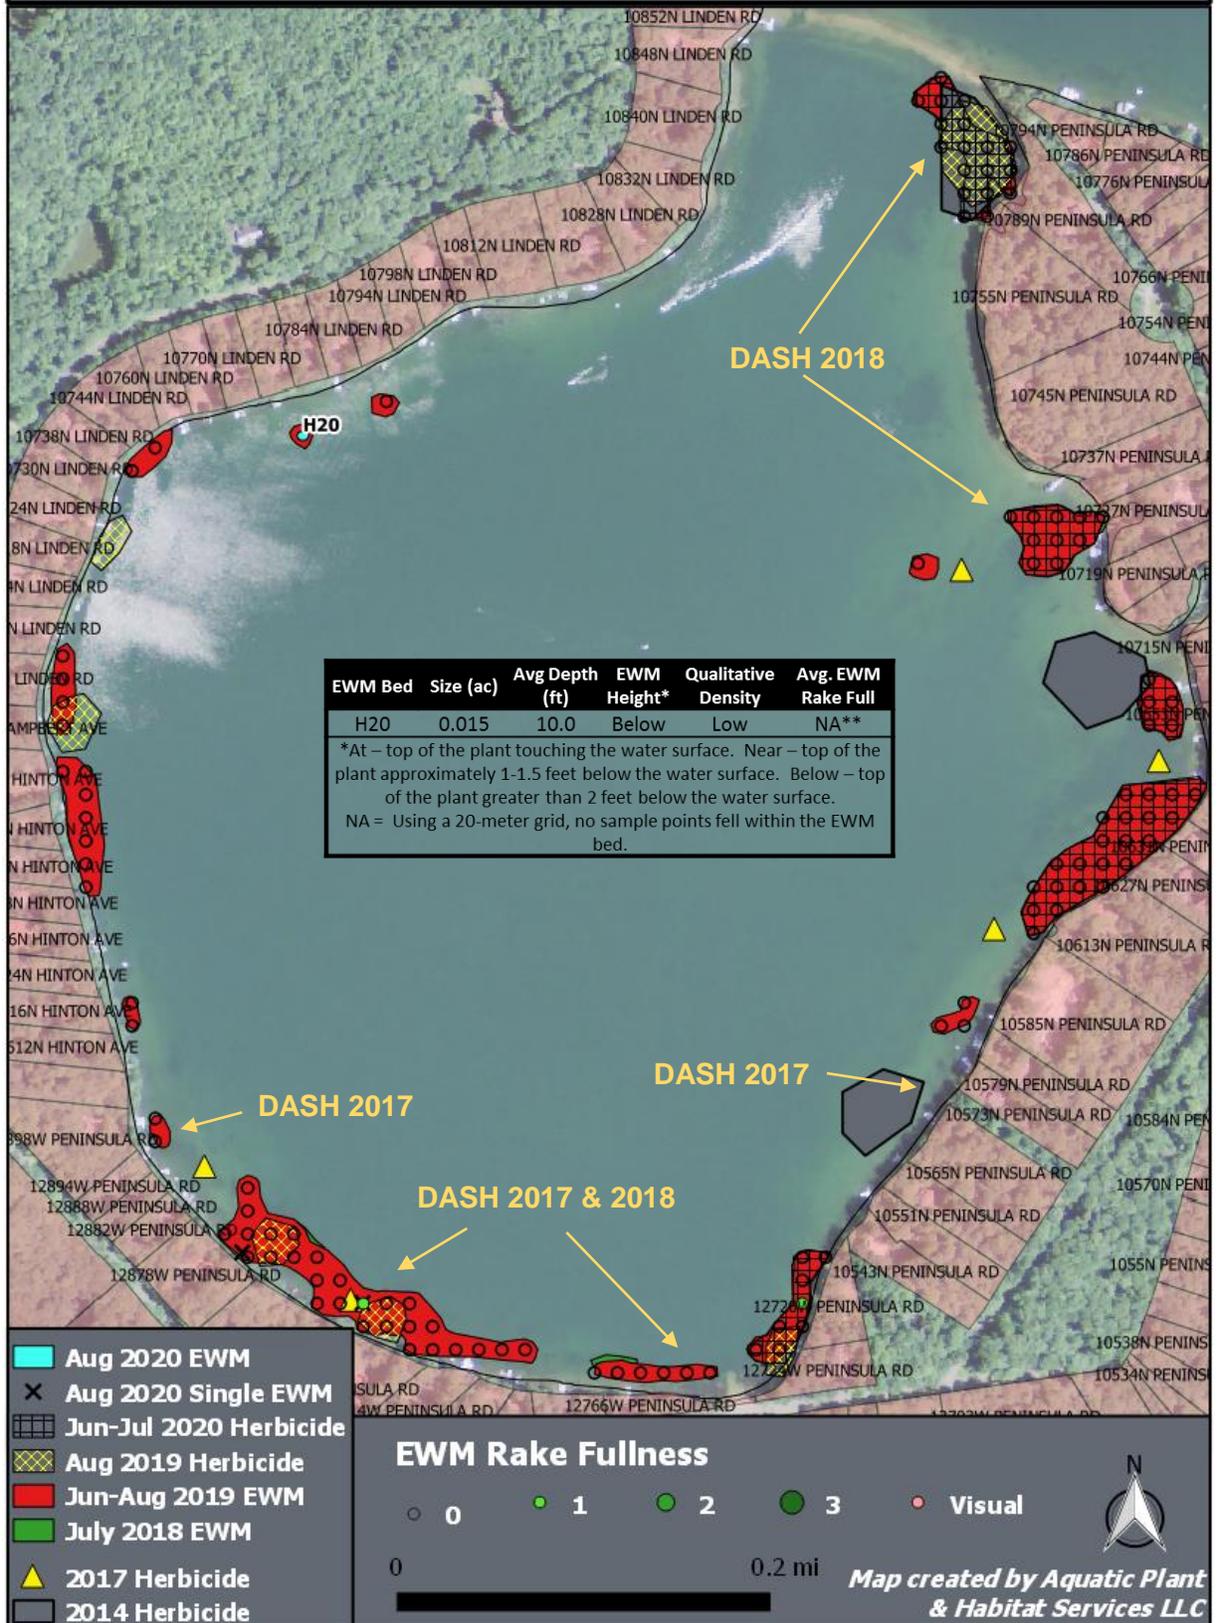
Map 1- Hinton Bay, Round Lake, Sawyer County, Wisconsin Eurasian Watermilfoil Occurrence & Management 2018-2020

There was a striking reduction of EWM occurrence in Hinton Bay with 0.015 acres mapped in August 2020 compared to 9.5 acres in June 2019 and 1.5 acres in July 2018.

The recent management history of Hinton Bay is somewhat complex. DASH was used to control EWM in four locations in 2017 (approx. 1.9 ac). Herbicide was also used in 2017 at 5 locations (3 ac). DASH efforts continued in 2018 at 4 locations (approx. 1.45 ac) with no herbicide treatment in 2018. Surprisingly in June 2019, the EWM was found to have significantly increased to 9.5 acres and DASH was reportedly believed by many Hinton Bay residents to be the cause of that increase. Furthermore, it was unrealistic that DASH would effectively control the 9.5 acres of EWM in 2019 within the 5 days budgeted. Therefore, DASH was cancelled and did not occur in Hinton Bay in 2019. Instead, contact herbicide was used to control EWM at 6 locations in August 2019 (2.5 ac). The remaining EWM was then planned for control in spring 2020. When the time came for herbicide treatment in 2020, the EWM along the south and western shores totaling 4.3 acres in June 2019 (red polygons in Map 1) was essentially gone. Although contact herbicide was applied at only 1.5 acres within the 4.3-acres of EWM, it was applied during calm weather conditions in mid-August 2019 and targeted exact locations of EWM. In other words, the 4.3 acres of EWM mapped in June 2019 encompassed areas of EWM that ranged in density from “scattered” to “highly dominant” and the herbicide applicator only treated exact spots where EWM was found growing rather than treating the entire polygon of scattered EWM plants. The eastern shoreline polygons were treated in June 2020 as planned. The reason for significant EWM decline along the western and southern shore between 2019 and 2020 is likely due to the highly targeted approach in applying herbicide only where EWM was found growing in August 2019.

There were 117 sample points visited in 2020 among 18 EWM beds to gauge effectiveness of control efforts since 2018. EWM was only found at 2 sample points in 2020 (1.7% littoral frequency). This is a statistically significant reduction in EWM compared to 2019 when EWM was found at 61 of 109 sample points within EWM beds (56% littoral frequency). EWM occurrence was also significantly higher in 2019 than the EWM found in 2018 when EWM was found at 6 of 29 sample points (21% littoral frequency).

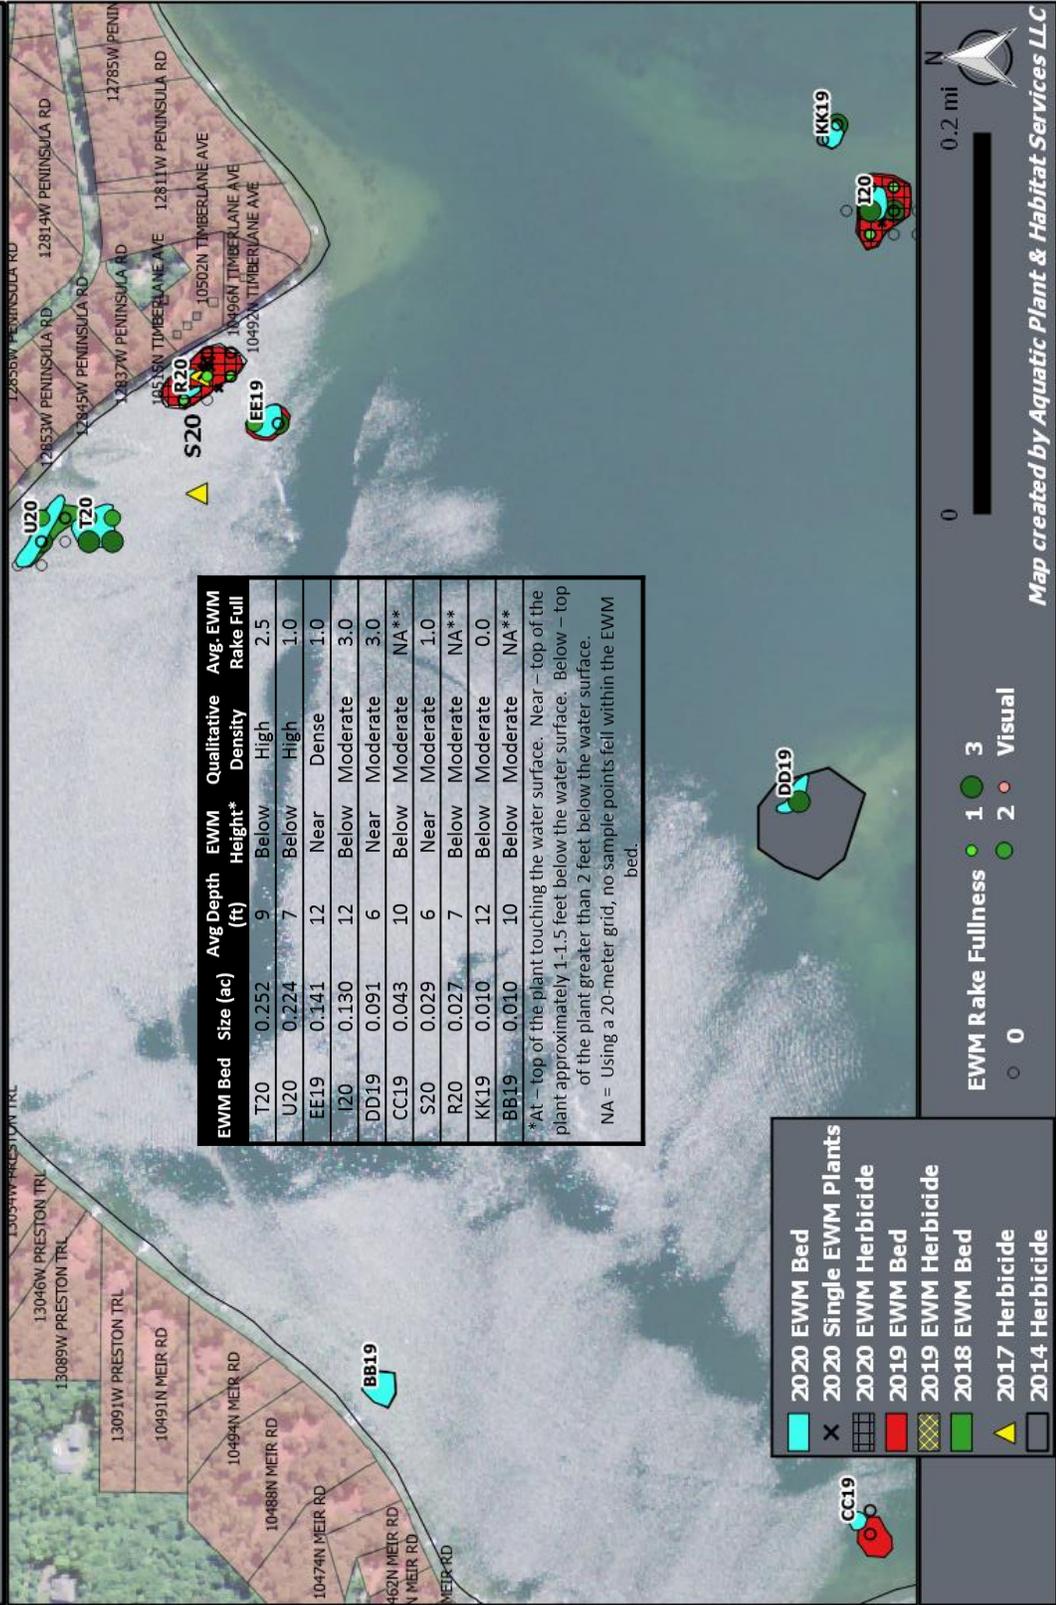
Map 2 - South of Peninsula, Far West, Clay's Bar, & Finger Bar, Round Lake, Sawyer County, Wisconsin Eurasian Watermilfoil Occurrence & Management 2018-2020

Total EWM in the large southwest section of Round Lake continued to be very low at 1.49 acres compared to 1.36 acres in 2019. There were 32 survey points within EWM beds and 17 of those sites had EWM present. The largest bed of EWM was located in southern Fisherman’s Bay (G20, Map 3) and was 0.46 acres. The next largest beds were quite small at approximate 0.25 acres each (T20 & U20, Map 2). The remaining beds of EWM were very small. The majority of EWM found was below the lake surface, i.e., the top of EWM plants were 2 ft. or more below the lake surface. During the survey, previously undocumented locations of EWM were noted. These areas include E20, F20, J20, and some scattered EWM plants in far southern Edgewater Bay.

The largest bed of EWM was located in southern Fisherman’s Bay (G20, Map 3) and was 0.46 acres. The next largest beds were quite small at approximate 0.25 acres each (T20 & U20, Map 2). The remaining beds of EWM were very small. The majority of EWM found was below the lake surface, i.e., the top of EWM plants were 2 ft. or more below the lake surface. During the survey, previously undocumented locations of EWM were noted. These areas include E20, F20, J20, and some scattered EWM plants in far southern Edgewater Bay.

An assessment of three DASH areas compared 2018 (pre-DASH) to 2019 & 2020 (post-DASH). Combining areas managed by DASH reveals EWM littoral frequency of 27% in 2018, 50% in 2019, and 86% in 2020 (Table 1). ***A chi-squared analysis confirms that the EWM increase from 2018 to 2020 is statistically significant.*** These results offer some insight on the use of DASH in these areas and suggest a single visit by DASH in 2018 did not reduce EWM in 2019 and 2020.

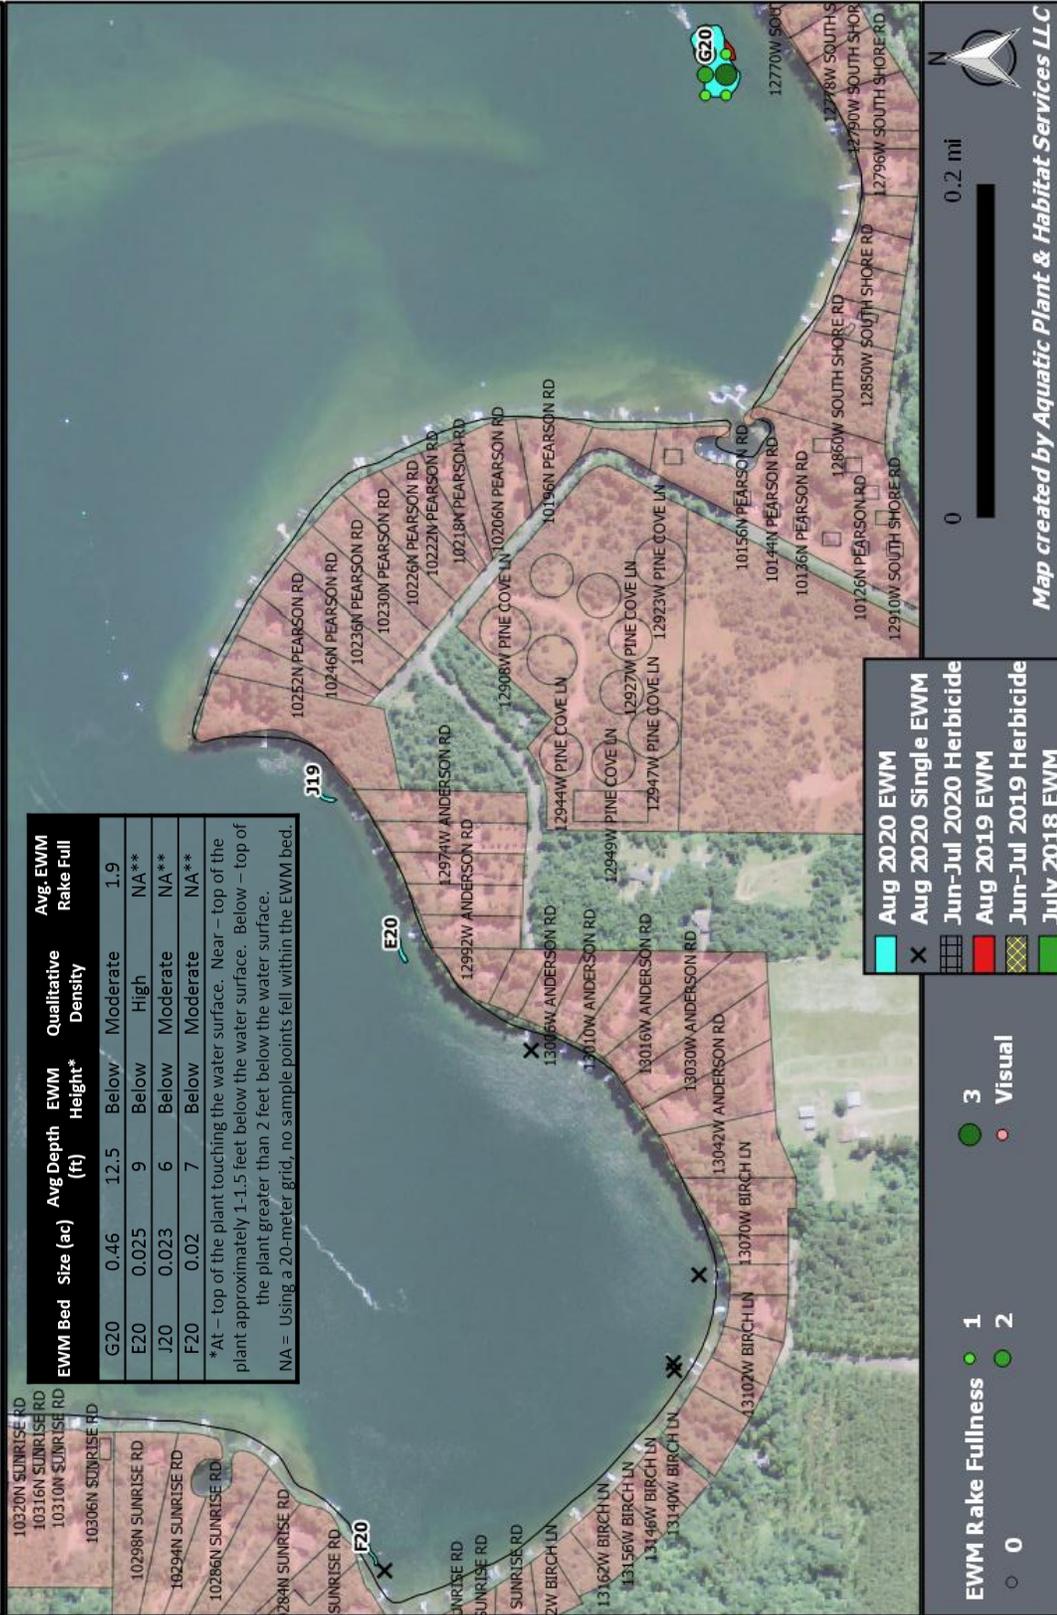
Map 3 - Fisherman's Bay & Edgewater Bay, Round Lake, Sawyer County, Wisconsin Eurasian Watermilfoil Occurrence & Management 2018-2020

EWM Bed	Size (ac)	Avg Depth (ft)	EWM Height*	Qualitative Density	Avg. EWM Rake Full
G20	0.46	12.5	Below	Moderate	1.9
E20	0.025	9	Below	High	NA**
J20	0.023	6	Below	Moderate	NA**
F20	0.02	7	Below	Moderate	NA**

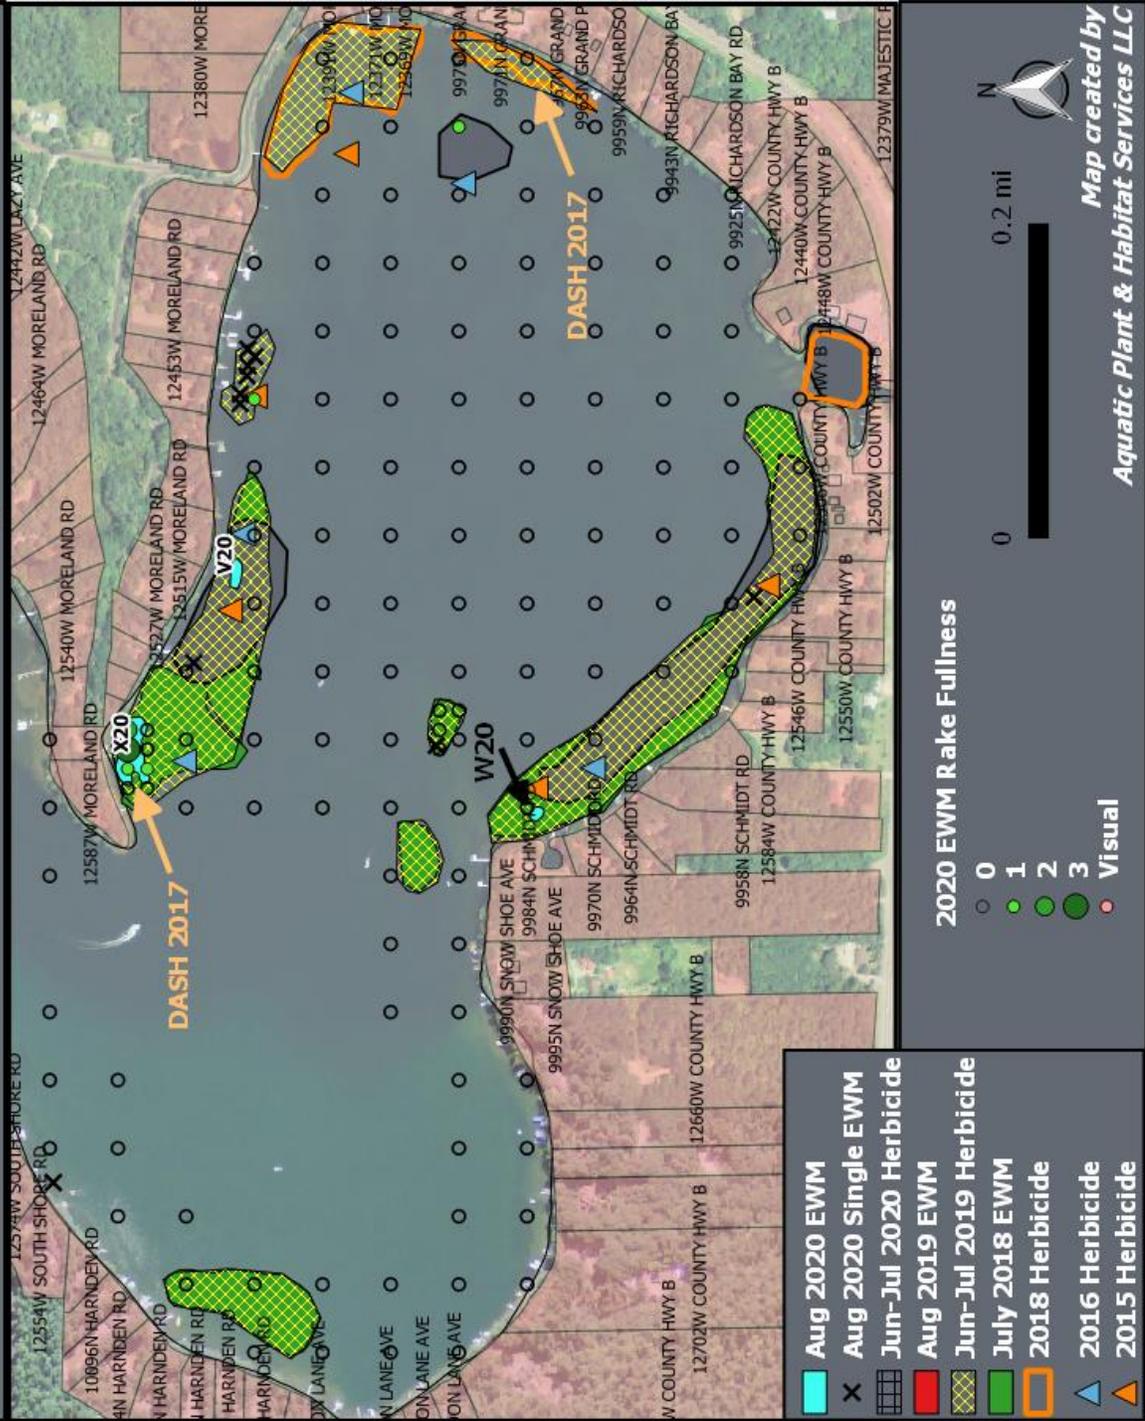
**Map 4 - Richardson's Bay, Round Lake, Sawyer County, Wisconsin
Eurasian Watermilfoil Occurrence & Management 2018-2020**

EWM in Richardson’s Bay was low in 2020 at 0.03 acres compared to zero acres in 2019 and 19 acres in 2018 before whole-bay herbicide treatment occurred.

No treatment occurred in Richardson’s Bay in 2020. An aquatic plant survey by APHS in late August found EWM at 2 sample points. APHS also delineated three beds of EWM, the largest of which was along the northern shore (X20, 0.4 acres). In addition to the beds of EWM delineated, there were scattered clumps of plants in a few locations (X’s on map), but particularly along the north central shoreline

The reduction in EWM from 2018 at 10 sample points down to 0 sample points in 2019 was statistically significant. The increase of EWM from 0 sample points in 2019 compared to 2 sample points in 2020 was not statistically significant. There were four native aquatic plant species that had statistically significant changes between 2018 and 2019: flat-stem pondweed increased from 15 to 32 points, wild celery increased from 44 to 67 points, horned pondweed decreased from 4 to 0 points, and white-stem pondweed increased from 0 to 9 points. There were three native species that had statically significant changes between 2019 and 2020: small pondweed increased from 6 to 17 points, wild celery decreased from 67 to 48 points, and perfoliate pondweed increased from 0 to 12 points.

EWM Bed	Size (ac)	Avg Depth (ft)	EWM Height*	Qualitative Density	Avg. EWM Rake Full
X20	0.397	7	Near & Below	Moderate	2.0
V20	0.065	7	Near	Moderate	NA
W20	0.037	6	Near	High	NA

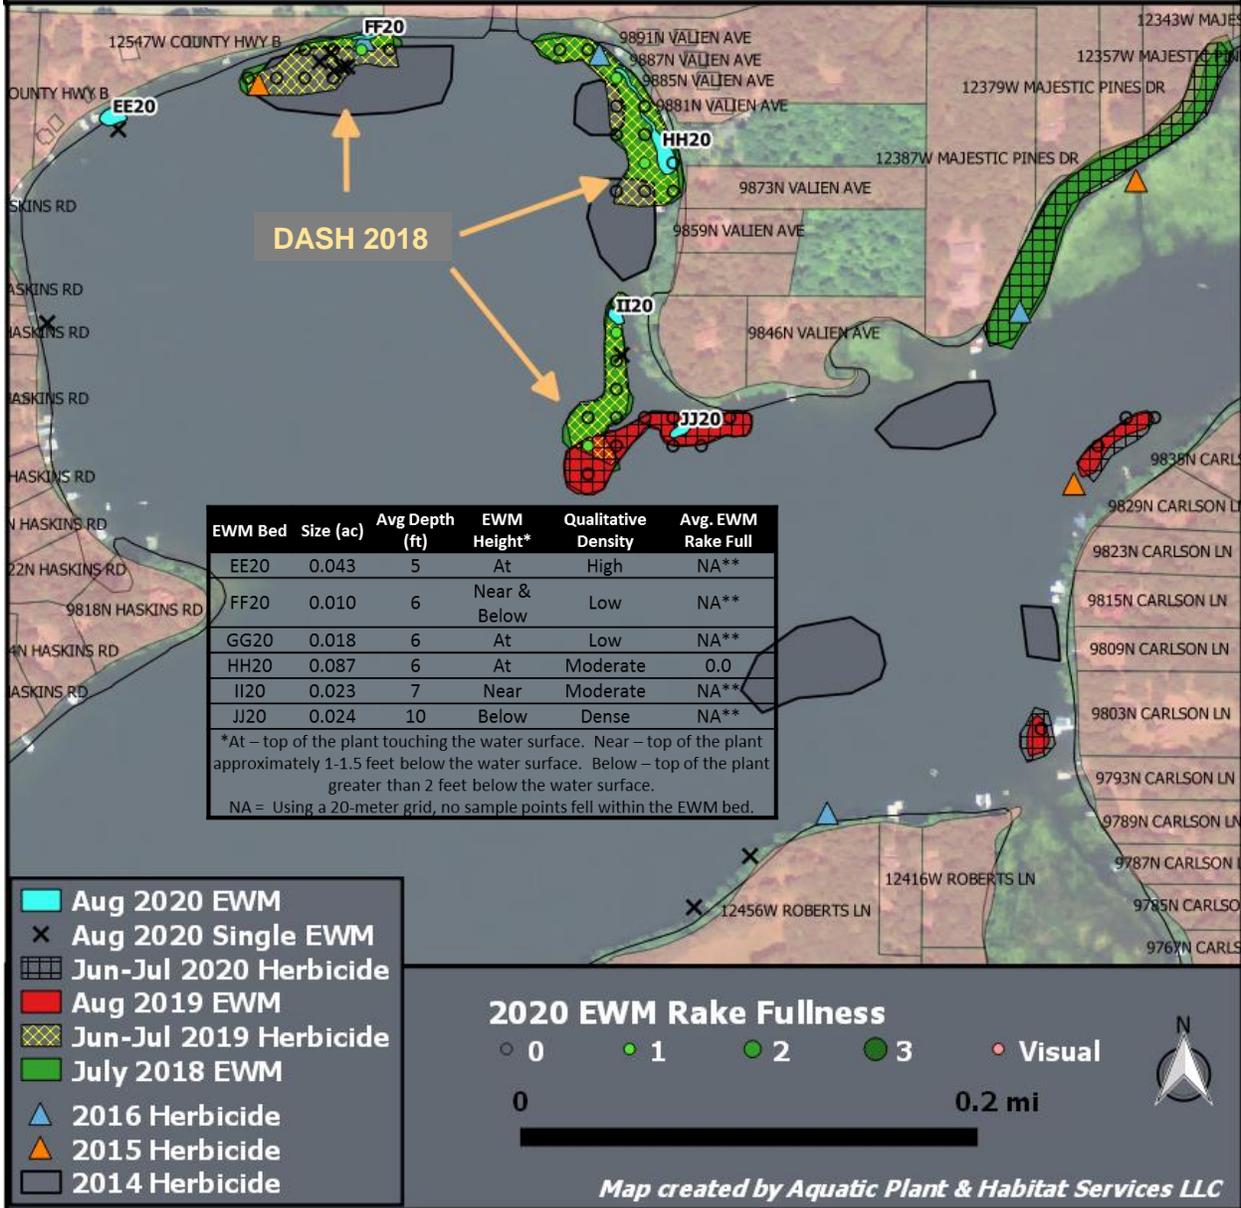
Map 5 - Northern Little Round Lake, Sawyer Co., WI Eurasian Watermilfoil Occurrence & Management 2018-2020

EWM was low in Little Round Lake in 2020 at 0.34 acres compared to 1.9 acres in 2019 and 5.5 acres in 2018.

There were four areas DASHed in 2018, but those areas were treated with herbicide in 2019. Therefore, the pre-post assessment of DASH as a control method 2018-2020 in those areas is not possible. These areas were decidedly too large for effective control after DASH technicians worked there for some time. Herbicide treatment followed in spring 2019 before a post-DASH assessment was possible. As displayed on Maps 5 and 6, five areas were treated with herbicide in 2019. Those areas were surveyed at 44 sample points in 2018, 2019, and 2020. In 2018, EWM was found at 27 points (littoral frequency 61%) compared to 11 points (littoral frequency 25%) in 2019 after herbicide treatment occurred in those areas. ***This reduction after the 2019 herbicide treatment was statistically significant.*** EWM continued to be low in those areas in 2020 with EWM found at only 8 sample points.

During the 2019 EWM survey of Little Round Lake, beds of EWM were delineated to provide some idea of location and size of EWM beds for future management but sample points within those beds was not part of the survey. Total EWM in Little Round Lake was estimated at 1.9 acres among 6 beds in 2019 (red polygons plus long narrow green EWM bed along Majestic Pines Dr., Maps 5 & 6). All of those area were treated with herbicide on June 23rd, 2020 and totaled 3.22 acres. A survey of 19 sample points in those areas in August 2020 found EWM at only 2 sample points.

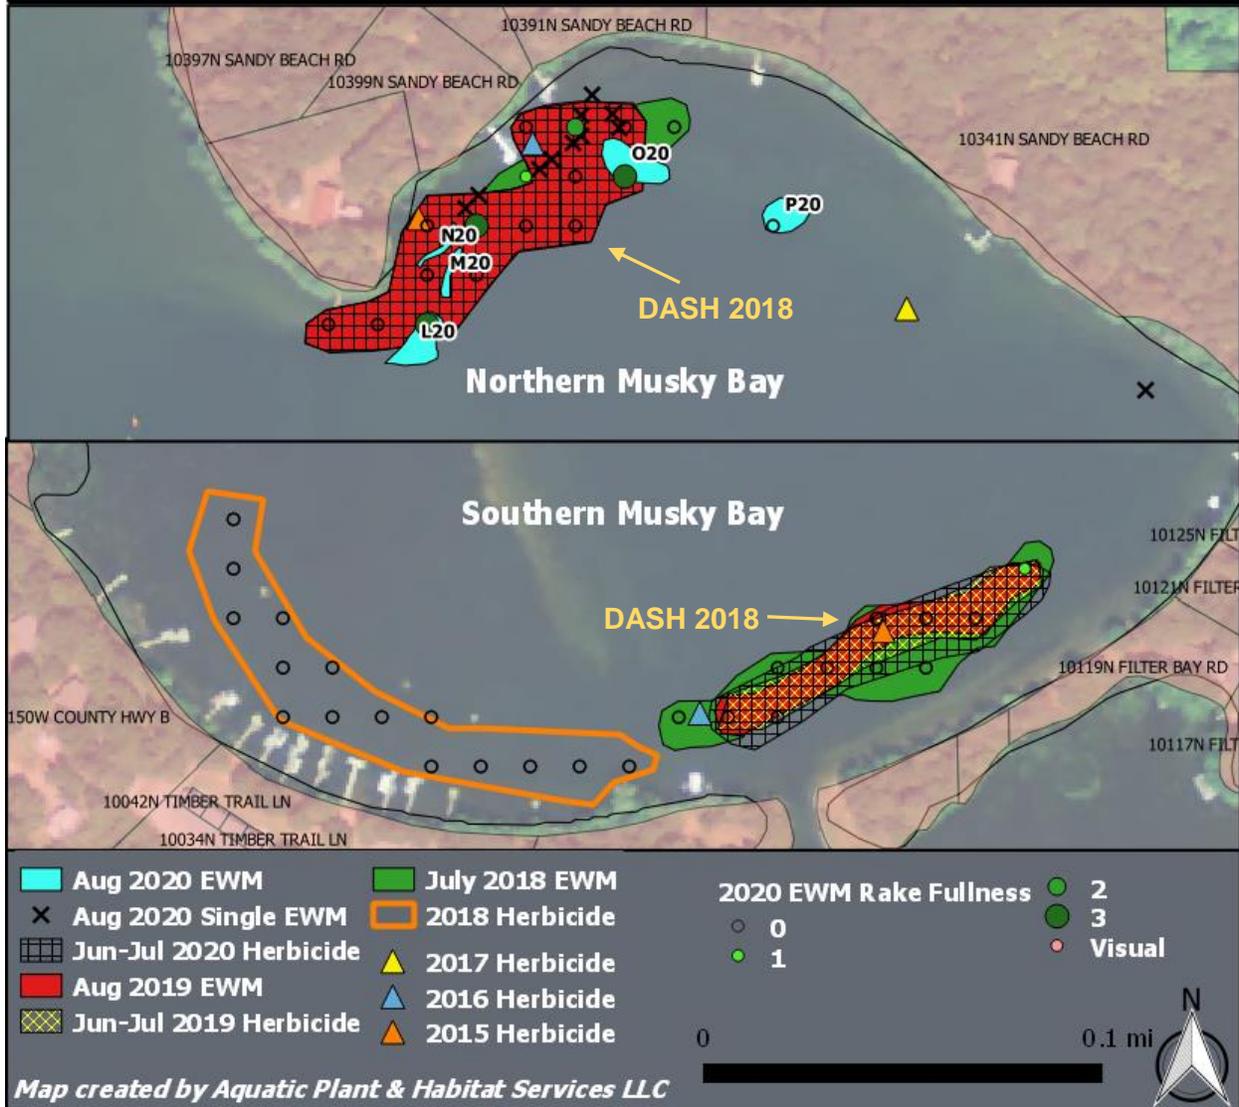
Map 7 - Northern & Southern Musky Bay, Round Lake, Sawyer Co, WI Eurasian Watermilfoil Occurrence & Management 2018-2020

EWM was low in Musky Bay in 2020 at 0.42 acres compared to 1.8 acres in 2019 and 3.1 acres in 2018.

One area in southwestern Musky Bay was treated with herbicide in 2018. Pre-treatment data was not collected, but post-treatment samples at 14 points found EWM at 3 points in 2019 and 0 points in 2020. ***This would suggest that the 2018 herbicide treatment continued to offer nuisance relief of EWM two full years after treatment.***

Herbicide treatment occurred on July 10th, 2019 at 1 acre in southeastern Musky Bay where DASH had also occurred in 2018. This area was sampled at 10 points in 2018 (pre-treatment) and 7 of those points had EWM. In 2019 (post-treatment), the same area was sampled at 11 points and EWM was found at 6 points. These findings suggest that the 2019 herbicide treatment was not successful in decreasing EWM occurrence within that treatment area in 2019. The area was treated with herbicide again in 2020 and only one sample point had EWM in August. ***This suggests that two consecutive years of herbicide treatment (2019-2020) resulted in significant decrease in EWM in this area.***

DASH was used in northern Musky Bay for 3 hours at 0.6 acres in 2018. That area of EWM grew from 0.6 acres in 2018 (before DASH) to 1.4 acres in 2019. In August 2019, that area was sampled at 17 points, 14 of which had EWM (82% littoral frequency). On June 22, 2020, the area was treated with herbicide on June 22, 2020. In August 2020, EWM was present at 5 sample points out of a total of 16 (31% littoral frequency), which is a statistically significant reduction compared to 2019. Also in 2020, 4 small remnant beds of EWM were still present within the treatment area and totaled 0.17 acres. ***This suggest that the 2020 herbicide treatment resulted in statistically significant decrease in EWM during the same year as treatment.***

EWM Bed	Size (ac)	Avg Depth (ft)	EWM Height*	Qualitative Density	Avg. EWM Rake Full
L20	0.067	11	Below	High	3.0
M20	0.013	11	Below	Moderate	NA**
N20	0.013	6	Near	Low	NA**
O20	0.075	8	Near	High	3.0
P20	0.047	12	Below & Near	Moderate	0.0

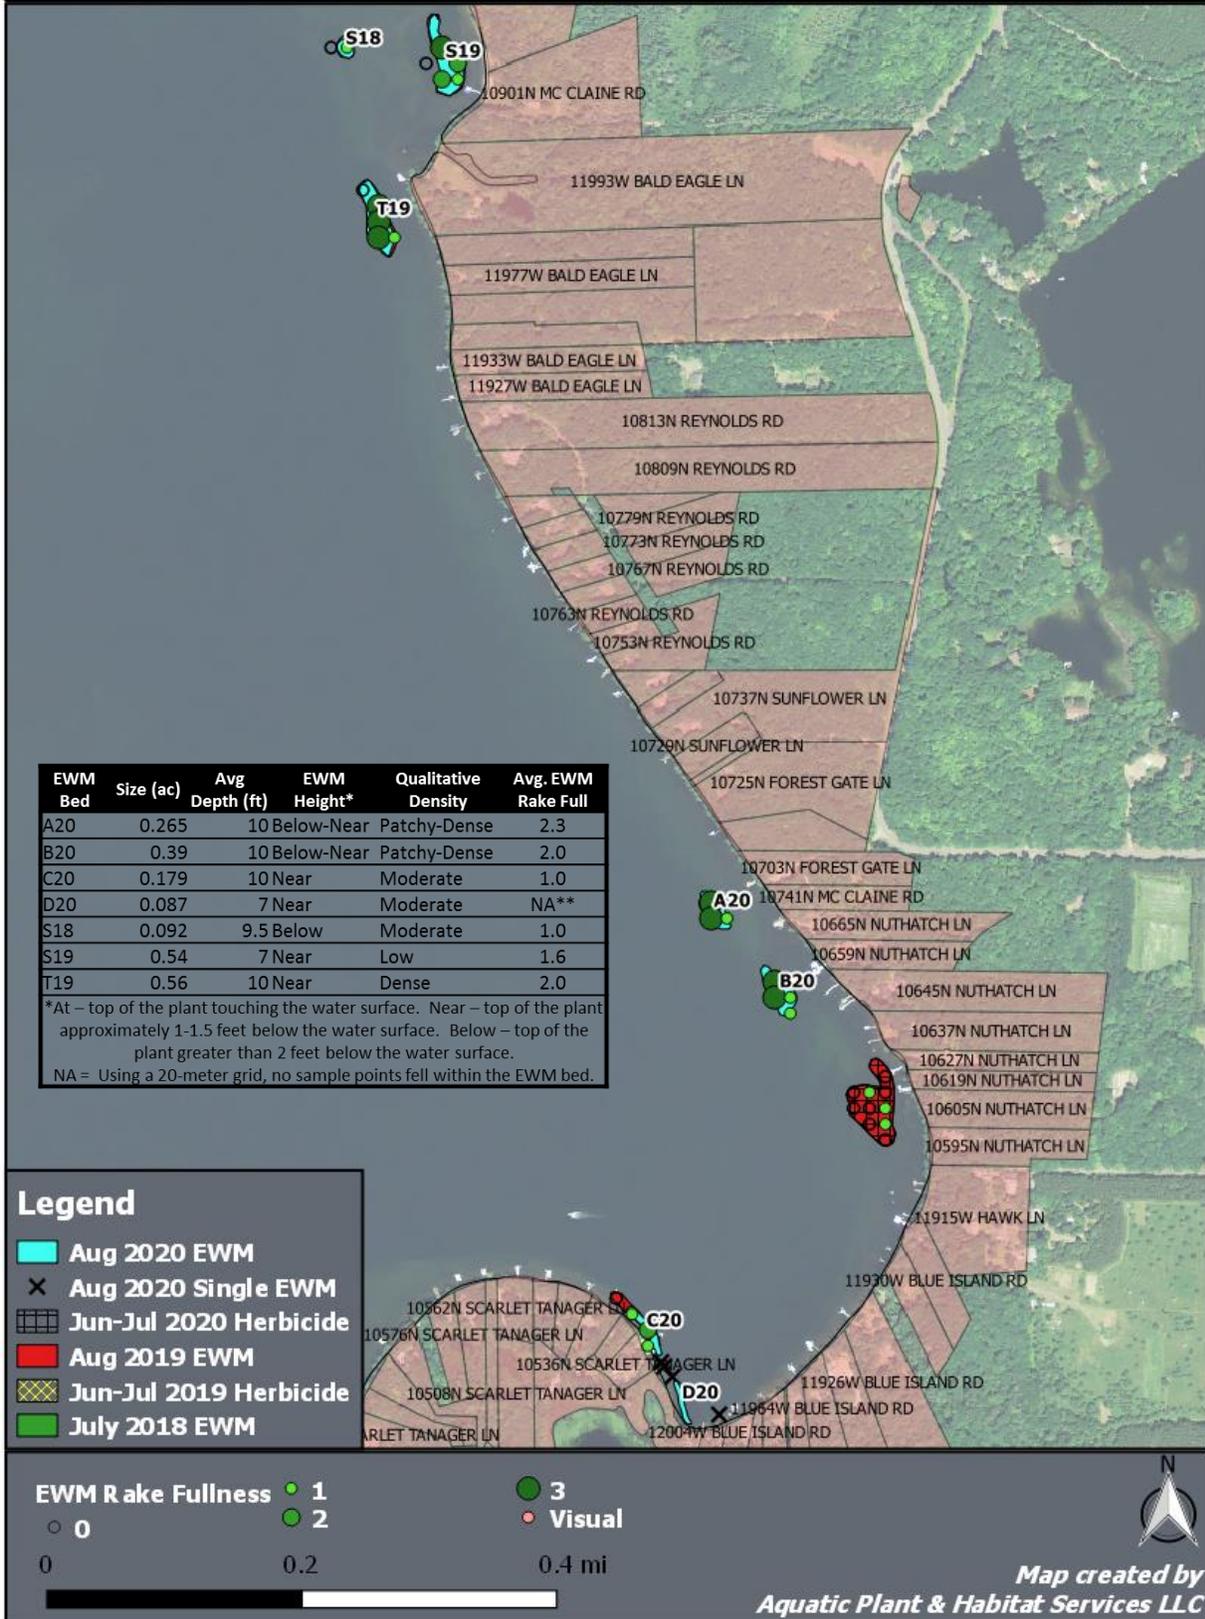
Map 8 - Blue Island Bay & Placid Inlet Area, Round Lake, Sawyer Co, WI Eurasian Watermilfoil Occurrence & Management 2018-2020

EWM was at 2.11 acres in this area of the lake in 2020 compared to 2.3 acres in 2019 and 0.1 acres in 2018.

An assessment of one DASH location was part of the survey to compare 2018 (pre-DASH) to 2019 and 2020. In 2018, 2019, and 2020, S18 was sampled at one point and EWM was on the rake at high density in 2018 and low density in 2019 and 2020. There was not enough EWM to delineate a bed in 2019 but there was enough to delineate a small 0.09 acre bed in 2020. This area is too small to capture enough sample points that would yield a statistically robust data set. Therefore, these results cannot be considered statistically significant. However, they can provide us with some insight and suggest ***a single visit by DASH in 2018 did reduce EWM in 2019 but the EWM returned to some degree in 2020.***

One acre of EWM was treated with herbicide in 2020. EWM was present at 7 out of 11 sample points in 2019 (64% littoral frequency). EWM was present at 3 out of 10 sample points in 2020 after herbicide treatment (30% littoral frequency). This decrease in EWM seems striking, but it is not statistically significant. Although EWM was detected at 3 sample points in 2020, the area was not considered a bed of EWM because it was mixed with native species and EWM was not visible as a bed from the lake surface. ***Even though the decrease is not statistically significant, EWM occurrence and density was clearly reduced during the same year as herbicide treatment.***

Three new or previously undocumented beds of EWM were delineated in 2020. A20 and B20 were two of the larger beds at 0.27 and 0.39 acres. EWM in the area of D20 was previously documented but at low and scattered densities. However, it was dense enough to delineate a small bed of EWM in 2020.

Three beds of EWM remained unaltered by management. C20 appears to be approximately the same size or even slightly smaller compared to 2019 (0.26 acres in 2019 and 0.18 acres in 2020). The northern-most portion of C20 was absent of EWM, which could have been a function of a property owner doing manual removal but this is not confirmed. T19 was the same in size and density compared to 2019. S19 was the same size, but increased in density from average rake fullness of 0.2 in 2019 to 1.6 in 2020.

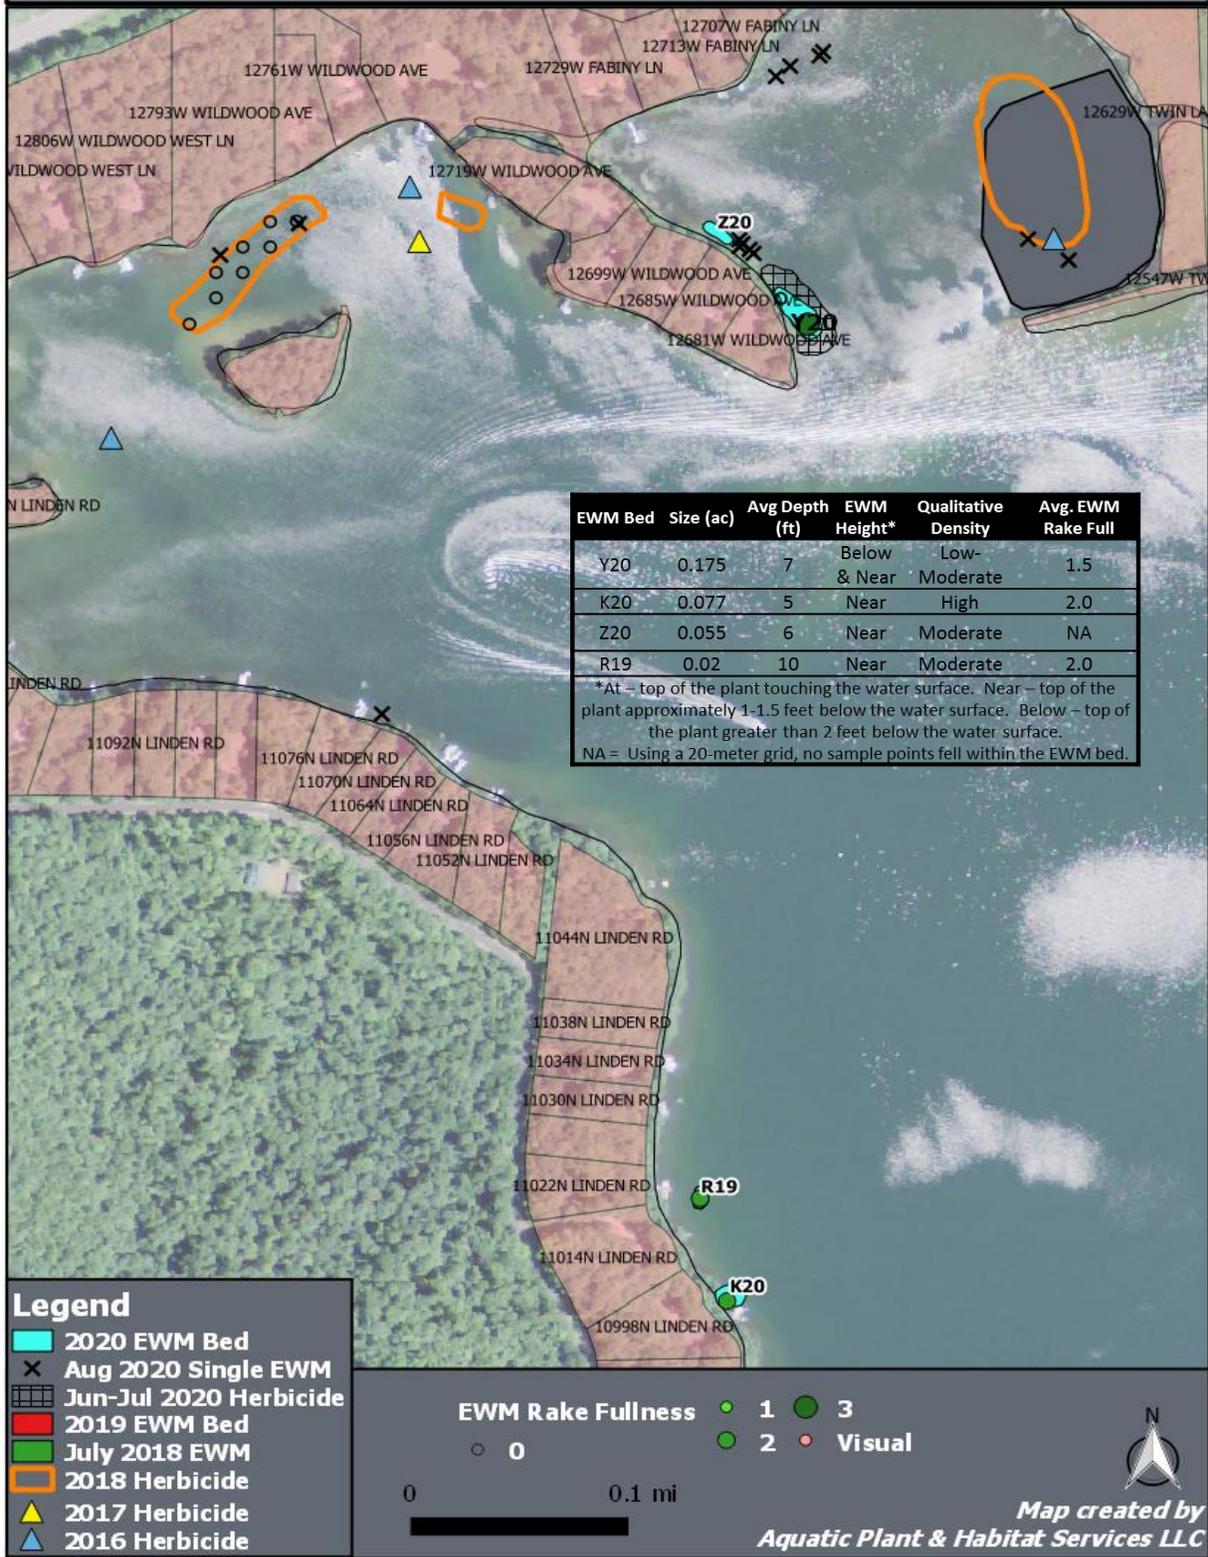
Map 9 - Northwest Round Lake, Sawyer County, Wisconsin Eurasian Watermilfoil Occurrence & Management 2018-2020

EWM was at 0.327 acres in this area of the lake in 2020 compared to 0.02 acres in 2019 and 3 acres in June 2018 before herbicide treatment occurred in late June and early July 2018.

No DASH has been done in this area of the lake. Herbicide treatment done at 3 acres in 2018 appears to continue to be effective in controlling EWM, however, pretreatment rake sample data was not collected in these areas. Even so, boating around these areas yielded only scattered, small clumps of EWM plants. ***Despite the lack in pre-treatment rake sample data, it appears the herbicide treatment from 2018 continues to be effective in controlling EWM.***

In Schoolhouse Bay there were two small beds of EWM found (Z20 & Y20). Between the two beds were several scattered, single EWM plants. Heading south out of Leder Bay and along the western shore were two small beds of EWM, one of which was the same size and location as 2019 (R19) while the other was newly documented in 2020 (K20). The total EWM in this area of the lake was low at 0.3 acre.

Herbicide treatment was done at 0.5 acres in 2020. There were two rake samples taken within this area and 0.18 acre of EWM delineated after the herbicide treatment. Despite the lack in pre-treatment rake sample data, it appears the herbicide treatment in 2020 may not have been as successful as other areas.
